Intel® Celeron® Processor in the 478-Pin Package

Specification Update

August 2003

Document Number: 290749-013

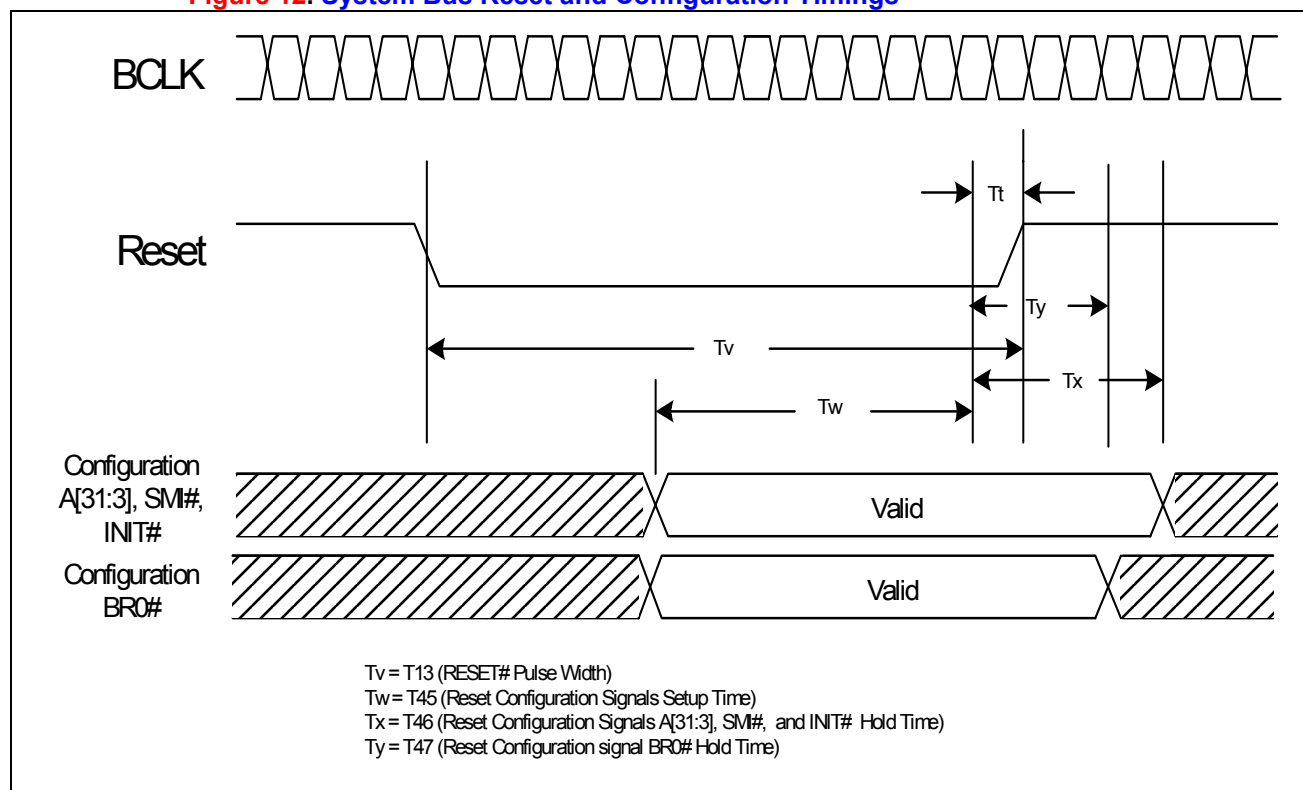
Figure 12. System Bus Reset and Configuration Timings

The BR0# maximum hold time has changed to 2 BCLKs. This change will be shown in the “System Bus AC Specifications (Reset Conditions)” table and “System Bus Reset and Configuration Timings” figure of the *Intel (R) Celeron (R) Processor on .13 Micron Process in 478-Pin Package Datasheet*. This change will be incorporated in the next revision of the Datasheet.
